SANDIA REPORT

SAND2003-3430

Assessment of the Non-Destructive Nature of PASD on Wire Insulation Integrity

Steven F. Glover, Matthew B. Higgins, Gary E. Pena, Larry Schneider

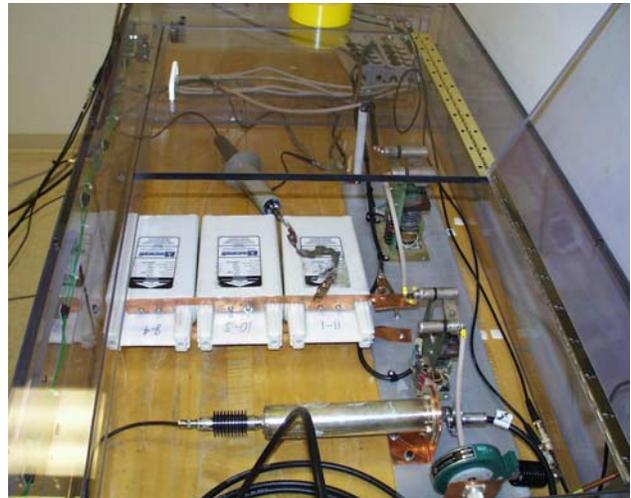
Figure 12. Large energy deposition experimental layout. Energy storage capacitors are white objects in center, current monitors are shown below.

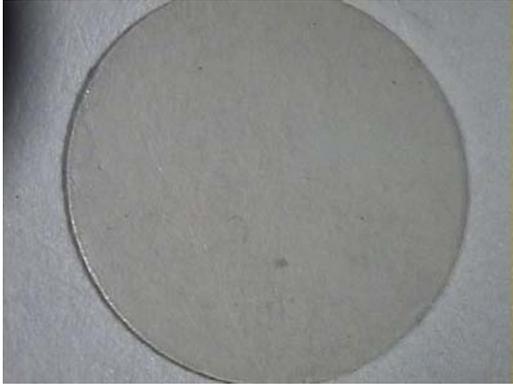
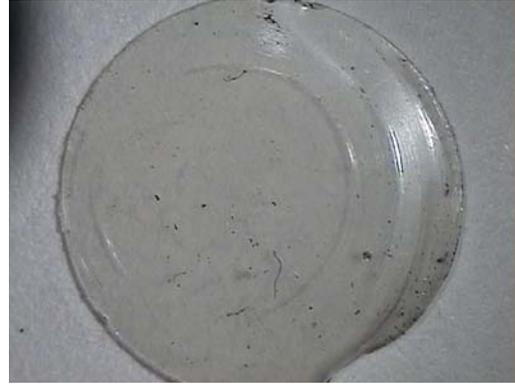
Figure 51 and Figure 52 contain photographs of a mylar sample before and after a low energy discharge. Notice the contamination (specs) apparent in Figure 52 following the low energy discharge. Since this contamination is located in areas not in the discharge path they were likely to have been in the fixture prior to the test. The important item to note is the lack of evidence in the photograph of damage to the insulator as a result of the discharge.

Figure 51. Microscopic photograph of a mylar sample before a low energy breakdown.

Figure 52. Microscopic photograph of a mylar sample after a low energy breakdown.

Additionally, since an understanding of the source of the specks of contamination seen in Figure 52, Figure 54, and Figure 56 is not known, further tests involving before and after photographs are recommended in order to determine any patterns and the probable source.

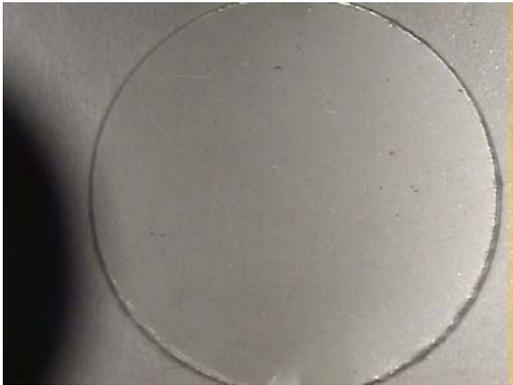
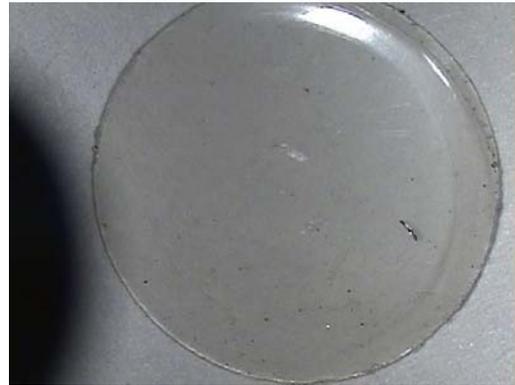
Figure 53 and Figure 54 contain photographs of a mylar sample before and after a PASD pulse. Notice the contamination (specs) apparent in Figure 54 following the PASD pulse. This contamination is significantly less than the contamination apparent in Figure 52. It is unclear whether the PASD pulse removed some of the contamination or there was less contamination in the fixture during the test. Again the important item to note is the lack of evidence in the photograph of damage to the insulator as a result of the discharge.

Figure 53. Microscopic photograph of a mylar sample before a PASD pulse.

Figure 54. Microscopic photograph of a mylar sample after a PASD pulse.

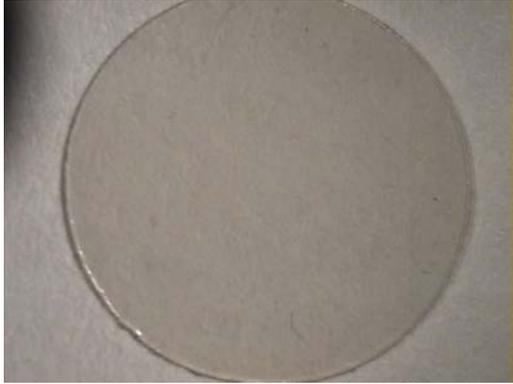
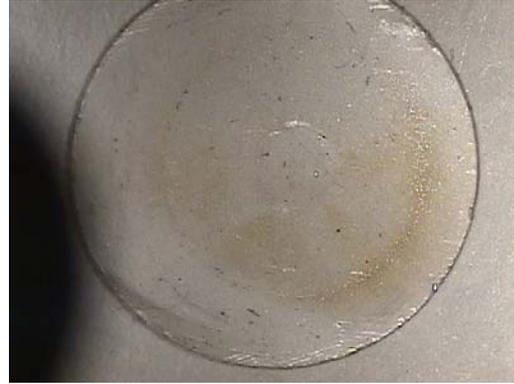
Figure 55 and Figure 56 contain photographs of a mylar sample before and after a high energy discharge. Notice the material deposition apparent in Figure 56. This material deposition is suspected to be metal removed from the BNC connector pin depicted in Figure 6. This deterioration is evident by looking at the photograph of this pin in Figure 57. This deposition supports the observation section 3.3 of the high energy discharge affecting the low energy voltage breakdown of the mylar samples.

Figure 55. Microscopic photograph of a mylar sample before a high energy discharge.

Figure 56. Microscopic photograph of a mylar sample after a high energy discharge.

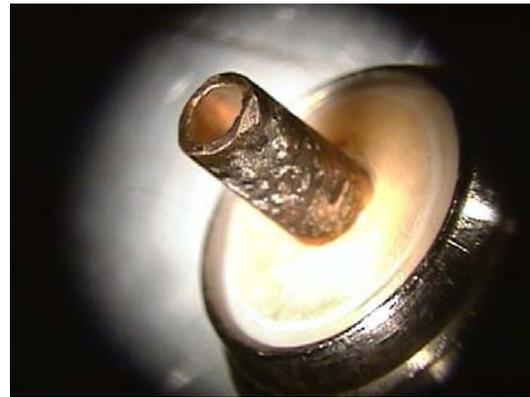
Figure 57. BNC connector pin located in the arc test fixture.
